**Flood Control Project Maintenance  
Levee Inspections**

**Maintenance Issue Types Only, Levee Inspection Report By Mile - Fall 2018**

**Reclamation District No. 1001 Nicolaus**

Waterway	Bank	Unit Miles	Inspection Start/End	Inspector
Unit No. 01 Yankee Slough	Right	4.12	10/09/2018 10/09/2018	Sterling York

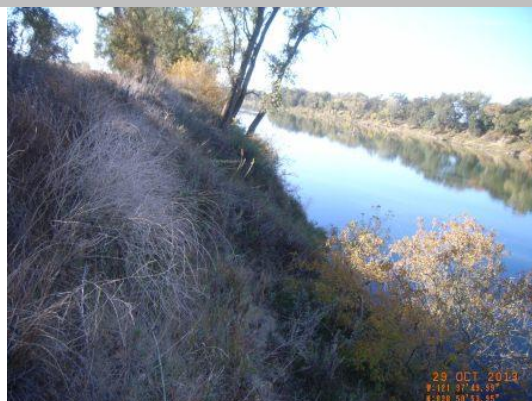
Photo 1 of 1 : FA\_2018\_RD1001\_38\_14\_20181114\_00013.jpg

LM Start	7.47	Rating **	U	Issue No.	14
LM End	7.79	Issue Type +	Ma	Location *	WS
Category	Supplemental			GPS Latitude/Longitude	
				Start	End
Item	2017 USACE Erosion Survey, DRAFT			38.852394 °	38.848004 °
				-121.629231 °	-121.630873 °
DWR ID	DWR_RD1001_04_f_2018_14				
Comment Code					
Inspector Comment					
2017 Site ID: FHR 5.0 L					
Status: Critical					
2017 Field Notes: Upgraded to critical, significant new erosion, entire bank slope is vertical with non cohesive soils.					
Site History: 2000 - Steep bank off berm with some slumps and fallen trees, continued erosion. 2002 - Site lengthened upstream and downstream due to vertical bank along most of the reach. 2010 - Site extended upstream. 2011 - Minimal new erosion. 2012 - Site extended on the upstream end, new tree pop-out, and bank erosion continues to worsen. 2013 - Minor new erosion at the toe and top of bank.

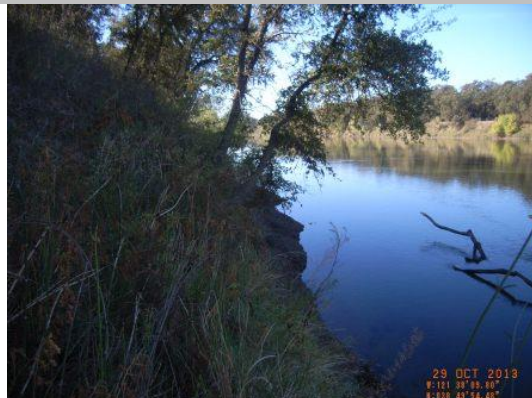
Photo 1 of 1 : FA\_2018\_RD1001\_38\_13\_20181114\_00012.jpg

LM Start	8.57	Rating **	A/W	Issue No.	13
LM End	8.97	Issue Type +	Ma	Location *	WS
Category	Supplemental			GPS Latitude/Longitude	
				Start	End
Item	2017 USACE Erosion Survey, DRAFT			38.836966 °	38.831498 °
				-121.634128 °	-121.636371 °
DWR ID	DWR_RD1001_04_f _ 2018_13				
Comment Code					
Inspector Comment					
2017 Site ID: FHR 3.8 L					
Status: Eroding					
2017 Field Notes: New erosion along lower slope					
Site History: 2006 - Sandy, silty bank with intermittent pockets of erosion. Rotational failure and tree pop outs are most of the problem. Some upper slope fluvial erosion. 2010 - Site extended upstream. The lower Feather may benefit from a regional repair. 2011 - Site combined with 3.6. Minimal new erosion. 2013 - New erosion observed at bank toe. Trees on site now have exposed roots.

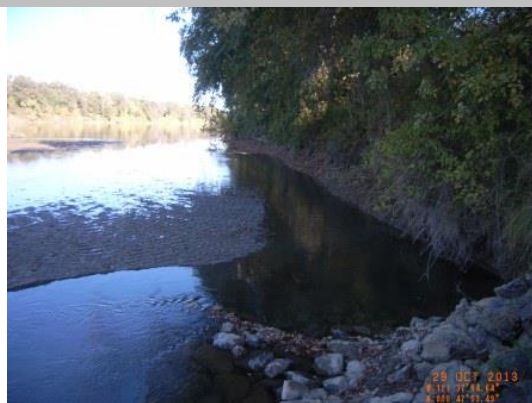
Photo 1 of 1 : FA\_2018\_RD1001\_38\_10\_20181114\_00007.jpg

LM Start	11.18	Rating **	M	Issue No.	10	
LM End	11.37	Issue Type +	Ma	Location *	WS	
Category	Supplemental			GPS Latitude/Longitude		
				Start	End	
Item	2017 USACE Erosion Survey, DRAFT			38.800920	°	
				-121.633050	°	
DWR ID	DWR_RD1001_04_f_2018_10					
Comment Code						
Inspector Comment						
2017 Site ID: FHR 1.0 L						
Status: Eroding						
2017 Field Notes: Significant new erosion along lower bank.						
Site History: 2000 - Site is relatively stable except for some toe erosion at the upstream end, recommend monitoring the upstream end. 2004 - Some new block failures (10ft deep) at the toe of the upstream end.						
2007 - Some minor new slumping at the waterline. 2013 - Minor new erosion along the bank toe.

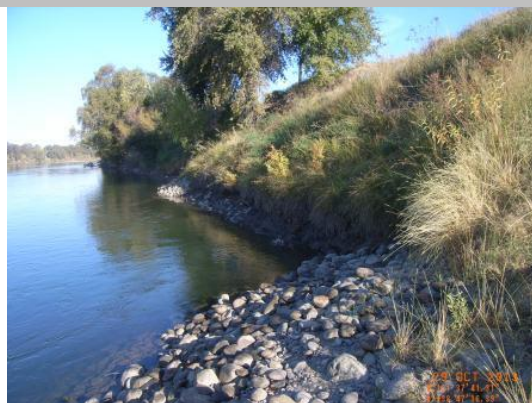
Photo 1 of 1 : FA\_2018\_RD1001\_38\_9\_20181114\_00002.jpg

LM Start	11.59	Rating **	M	Issue No.	9
LM End	11.75	Issue Type +	Ma	Location *	WS
Category	Supplemental			GPS Latitude/Longitude	
				Start	End
Item	2017 USACE Erosion Survey, DRAFT			38.795455 °	38.793394 °
				-121.629903 °	-121.628156 °
DWR ID	DWR_RD1001_04_f_2018_9				
Comment Code					
Inspector Comment					
2017 Site ID: FHR 0.6 L					
Status: Eroding					
2017 Field Notes: Further toe erosion, with sections of sand deposition.					
Site History: 1997- Deposits over top of cobble on the upper slope.					
2000 - Old cobble site in poor shape; some toe retreat, but little change; steep bank. 2010 - Site extended upstream due to new toe erosion.					
2012 - Minor new erosion at toe, new slumping, animals holes and cracks observed.

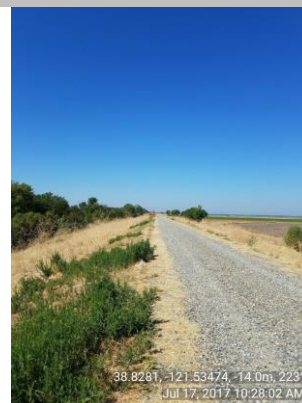
Photo 1 of 3 : LEVAL\_FA\_2018\_493\_1759.jpg

LM Start	5.05	Rating **	A/W	Issue No.	8	
LM End	5.06	Issue Type +	Ma	Location *		
Category	Supplemental			GPS Latitude/Longitude		
				Start		End
Item	2017 Storm Damage			38.828100°	38.828188°	
				-121.534740°	-121.534625°	
DWR ID	DWR_RD1001_05_f_2017_8					
Comment Code						
Inspector Comment						
Levee Evaluation Comments						
Description:						
Site ID No:493						
Site Designation:RD 1001-03						
Repair Type: Erosion						
Rating:Serious						
Field Date:7/17/2017						
Notes: Serious per senior review

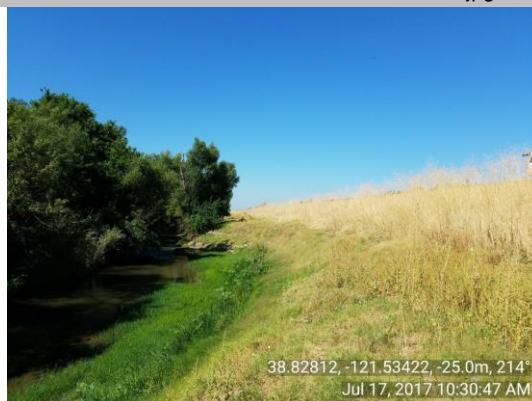
Photo 2 of 3 : LEVAL\_FA\_2018\_493\_1762.jpg

LM Start	5.05	Rating **	A/W	Issue No.	8 (cont)	
LM End	5.06	Issue Type +	Ma	Location *		
Category	Supplemental			GPS Latitude/Longitude		
				Start	End	
Item	2017 Storm Damage			38.828100 °	38.828188 °	
				-121.534740 °	-121.534625 °	
DWR ID	DWR_RD1001_05_f_2017_8					
Comment Code						
Inspector Comment						
Levee Evaluation Comments						
Description:						
Site ID No:493						
Site Designation:RD 1001-03						
Repair Type: Erosion						
Rating:Serious						
Field Date:7/17/2017						
Notes: Serious per senior review
